Investigation of the gen presence and formation of biofilms by *Staphylococcus* in a milk processing micro-dairy

S.S. Santos¹, M.I.M. Medeiros¹, V. Souza¹, P.C. Melo¹, L.F. Zafalon², J.L.A. Veschi³, A. Nader Filho¹

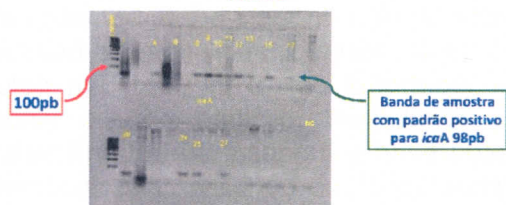
Figure 1 - Gen *icaA* positive in the columns 4, 6, 11, 12, 13, 20 e 24 (tank surfaces); 10 e 27 (pipes); a das columnas 1, 8, 9, 15, 17 e 25 (milk). NC: Negative control.
